# **Ice Jams in Lower St. Regis River Akwesasne, NY**

**Report submitted to  
Water Resources Program, Environment Division  
The Saint Regis Mohawk Tribe  
(Contract No. 19-0015)**

**Fengbin Huang and Hung Tao Shen**

**July 2020**

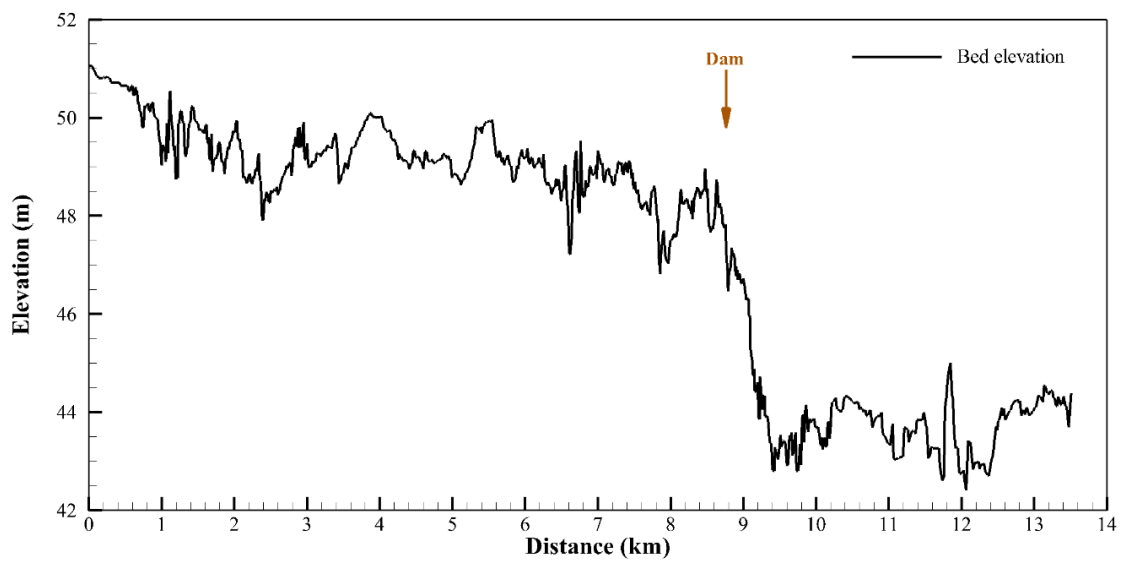
Figure 3. Simulation domain extending from the St. Lawrence River to Helena, NY, and the vicinity of the Dam.

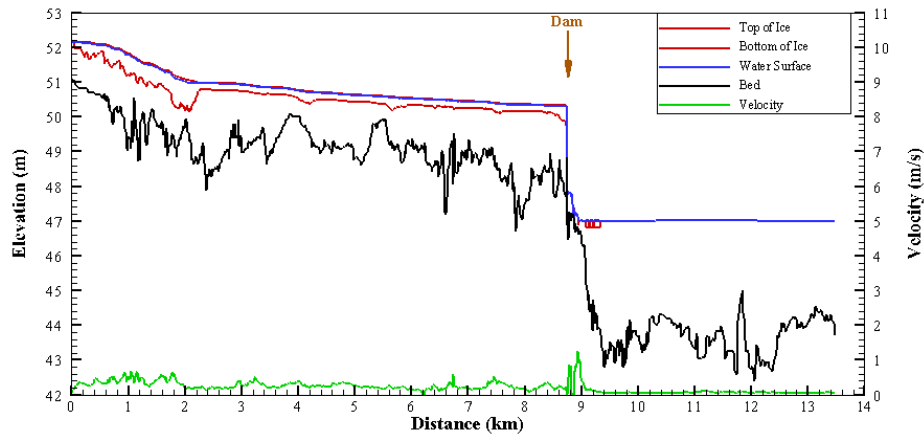
Figure 22. Longitudinal profiles of flow and ice conditions at hour 48,  $24.07 \text{ m}^3/\text{s}$  ( $850 \text{ ft}^3/\text{s}$ ) – Pre-dam-removal.

accumulation/jam near the bend exit. Figure 22, 23, 24, and 25 show the ice accumulation and the water surface profiles of the four scenarios when the flow and ice conditions are stabilized. The pre-dam-removal case showed ice accumulation at the dam under the lower flow condition of  $24.07 \text{ m}^3/\text{s}$  ( $850 \text{ ft}^3/\text{s}$ ). The removal of the dam allows more ice transport to downstream. Ice jamming occurs in the downstream pool and results in an increase in the water level downstream of the dam. This also occurs for the pre-dam-removal case under the high flow condition of  $39.64 \text{ m}^3/\text{s}$  ( $1400 \text{ ft}^3/\text{s}$ ). At the discharge of  $24.07 \text{ m}^3/\text{s}$  ( $850 \text{ ft}^3/\text{s}$ ), the dam removal leads to lower water levels upstream of the dam site and a mild jam formation in the bend. Another ice jam located near downstream of Helena at km 2.24 brings about the head loss and contributes to the lower water levels between the jam and Hogansburg. However, at the discharge of  $39.64 \text{ m}^3/\text{s}$  ( $1400 \text{ ft}^3/\text{s}$ ), the dam removal enhances the flow and ice transport past the dam site and results in a larger ice jam in the downstream pool. As a result, the water level at Hogansburg is higher than that of the pre-dam-removal condition. The localized thick ice accumulations at the upstream of the dam site increase the upstream water levels. Therefore, the water levels between the upstream jam and the dam site are higher than those for the pre-dam-removal conditions. Figure 26 shows the comparison of the water surface profiles for the four simulated cases.

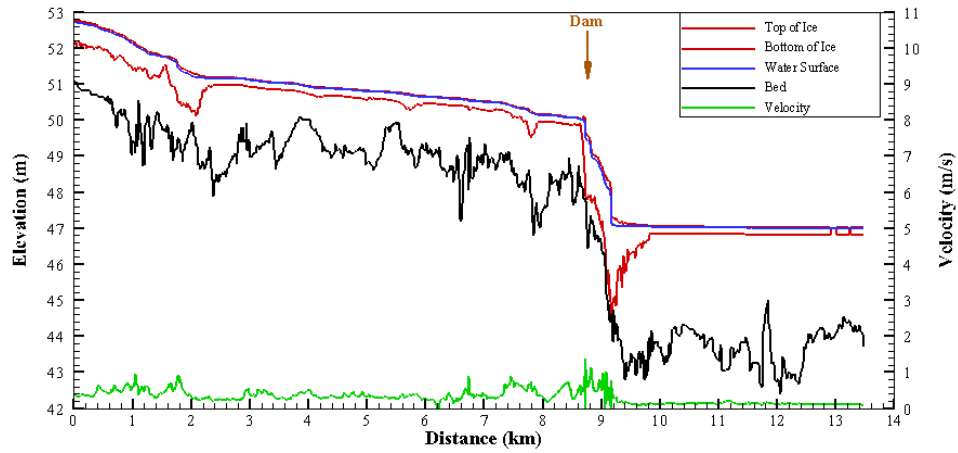
Figure 25. Longitudinal profiles of flow and ice conditions at hour 96,  $Q = 39.64 \text{ m}^3/\text{s}$  ( $1400 \text{ ft}^3/\text{s}$ ) – Post-dam-removal.

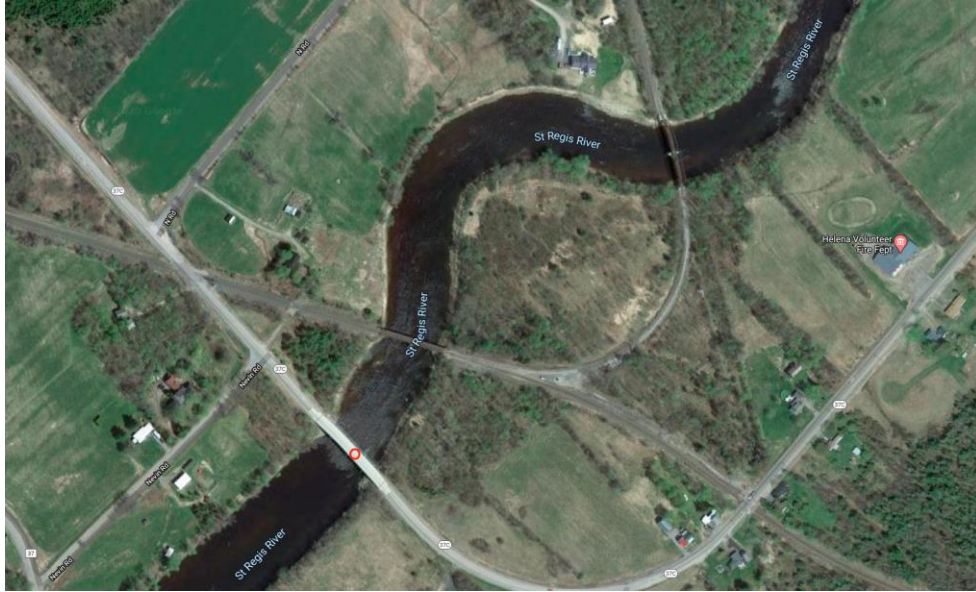
Figure 27. Key locations selected to summarize the ice thickness and peak water surface elevation.

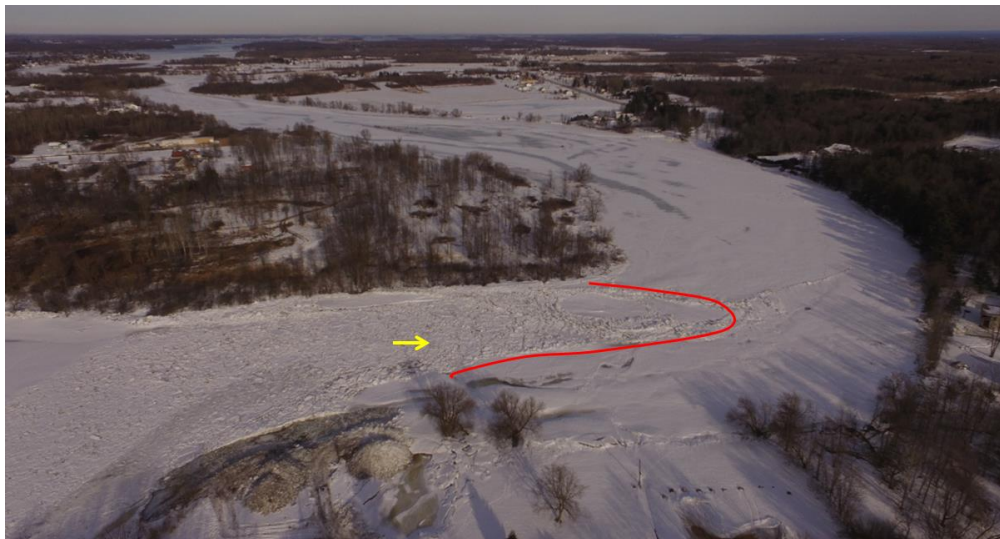
Figure 30. Aerial view of the ice jam toe on Jan. 30, 2020.

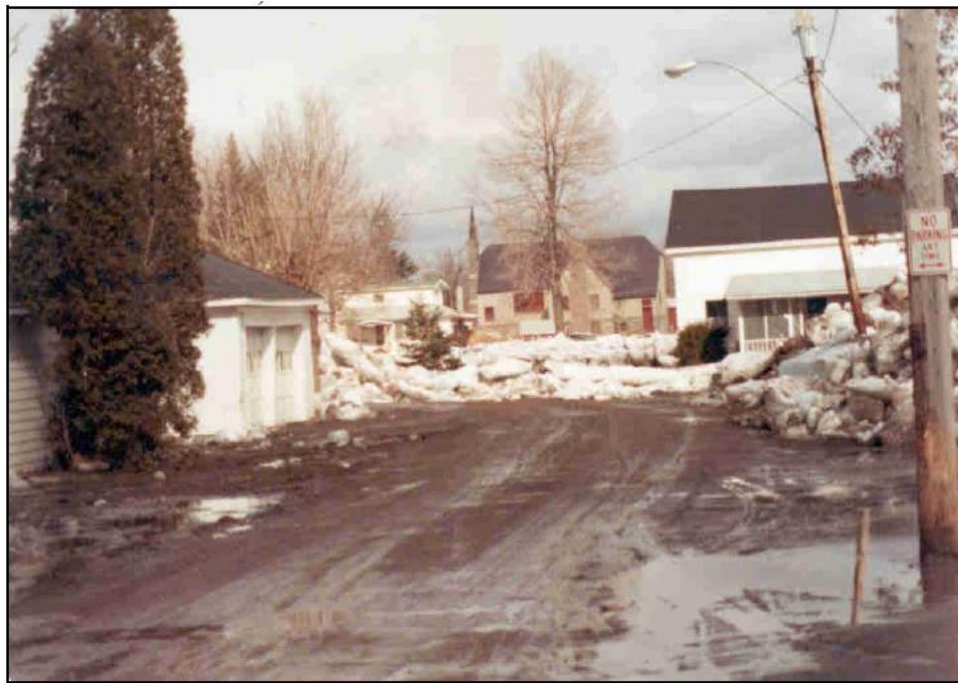
Figure 55. Ice jam damage on the SRMT reservation on Feb. 26, 1981. (Emery 1981)

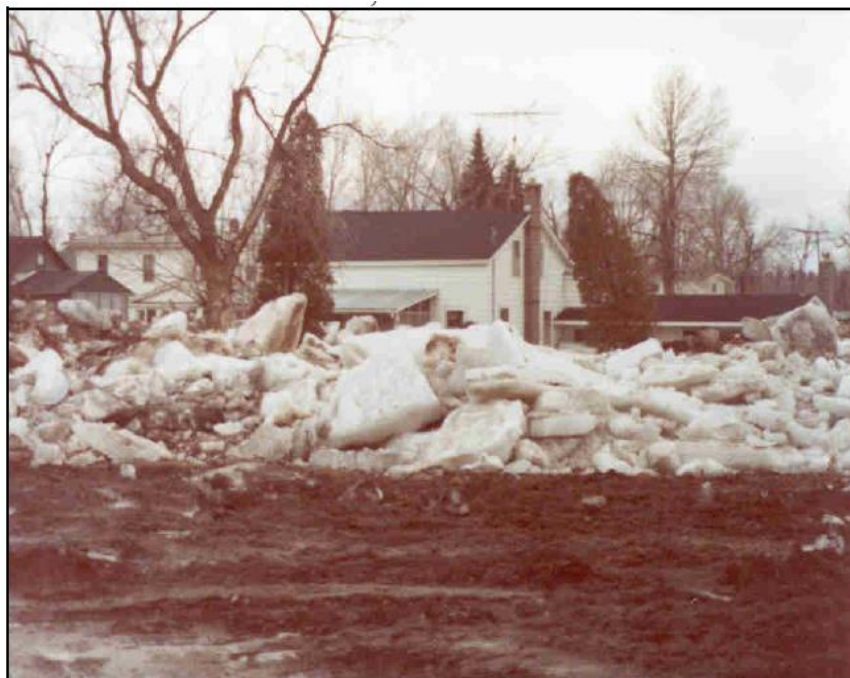
Figure 56. Ice deposited on the shoreline of the St. Regis River due to the ice jam flooding on Feb. 26, 1981. (Emery 1981)

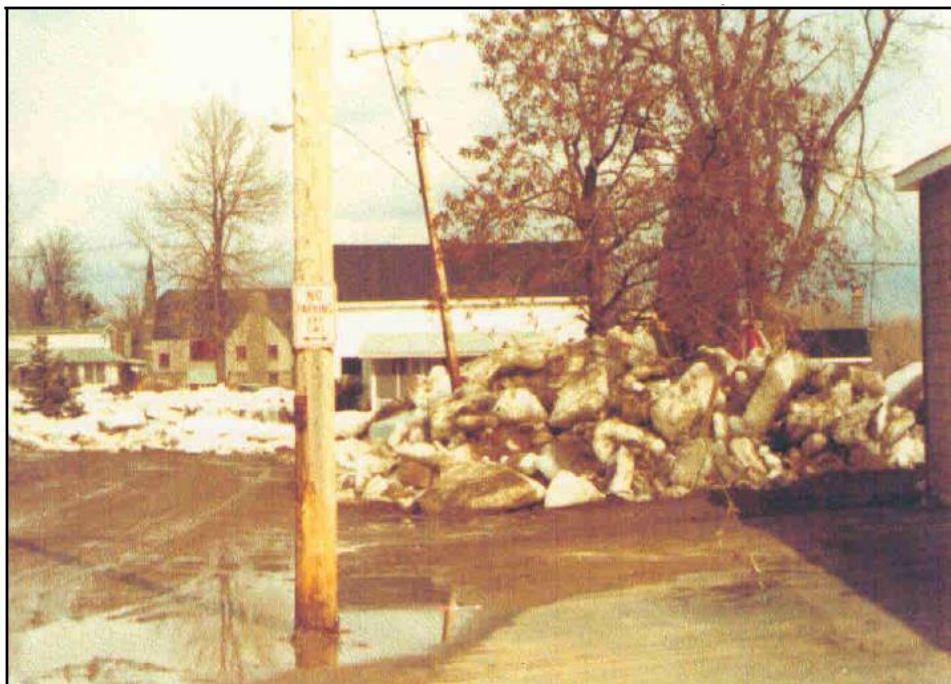
Figure 57. HAVFD station 1 on river left during the ice jam flooding on Feb. 26, 1981. (Emery 1981)

The Feb. 26, 1981 ice jam caused severe flooding, power outages, and property damage in Hogansburg (HDR, Inc. 2012). Failure of the jam occurred at approximately 10:20 PM on the evening of Feb. 26 (Emery 1981). Figure 54 shows the weather and flow conditions in mid and late February. There was a warm period before Feb. 26. The jam might have formed from the warm rainfall on Feb. 20-21, then released after the three consecutive days of warm air temperature and moderate rainfall on Feb. 26. The ice jam formed in the sharp bend downstream of the dam. The failure of the jam in the evening was probably due to the collapse of the ice cover at the jam toe. The strength of that ice cover deteriorated due to the melting associated with the warm air temperature and rainfall. Photos of ice jam flooding in the Hogansburg area are given by the SRMT Environmental Division (Emery 1981). Figure 55 to Figure 58 show the photos of the ice conditions at Hogansburg as a result of the ice jam flooding.

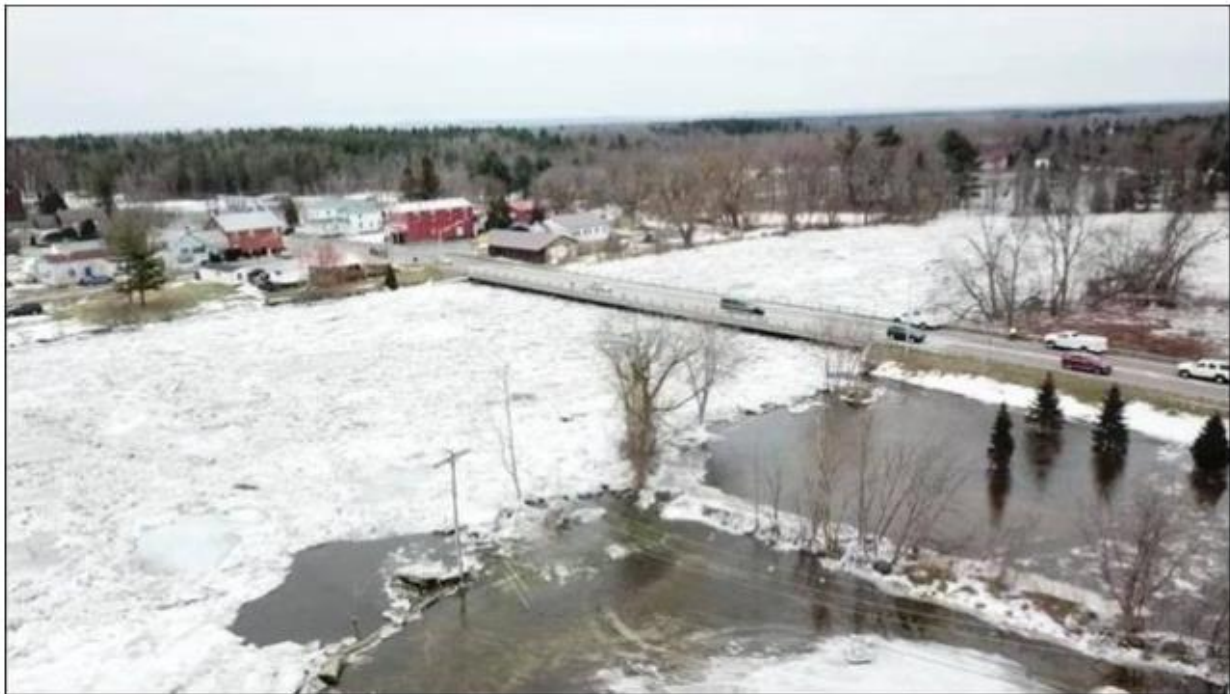
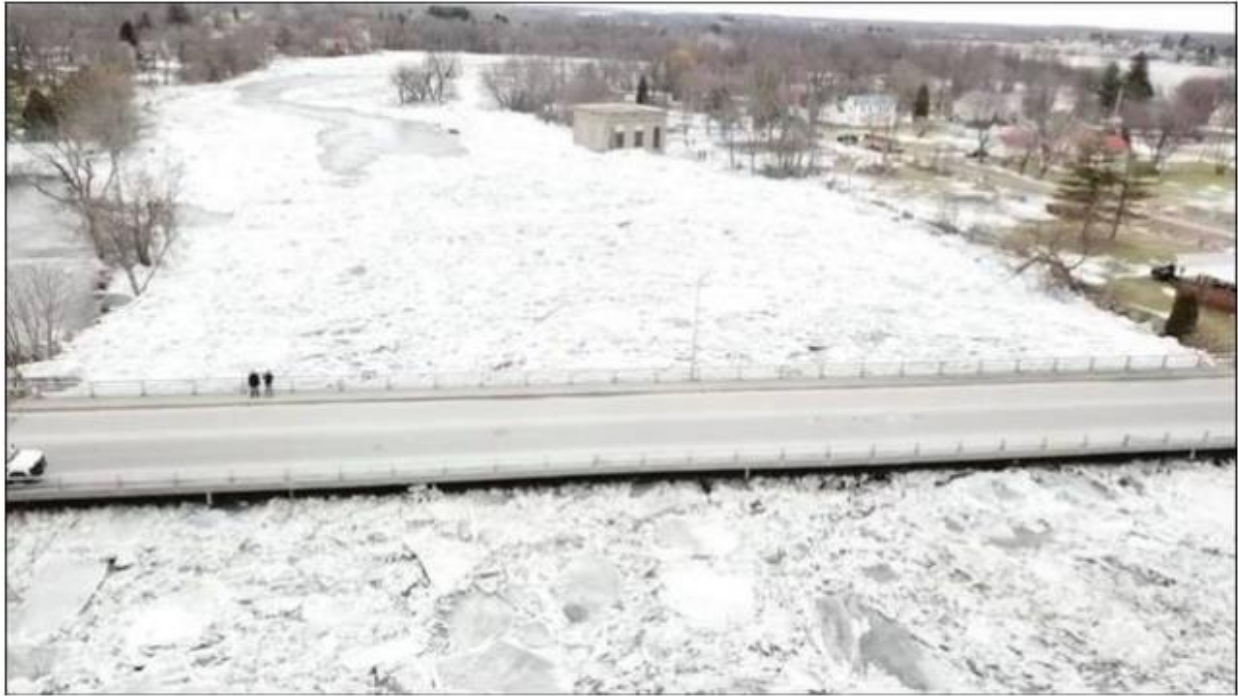
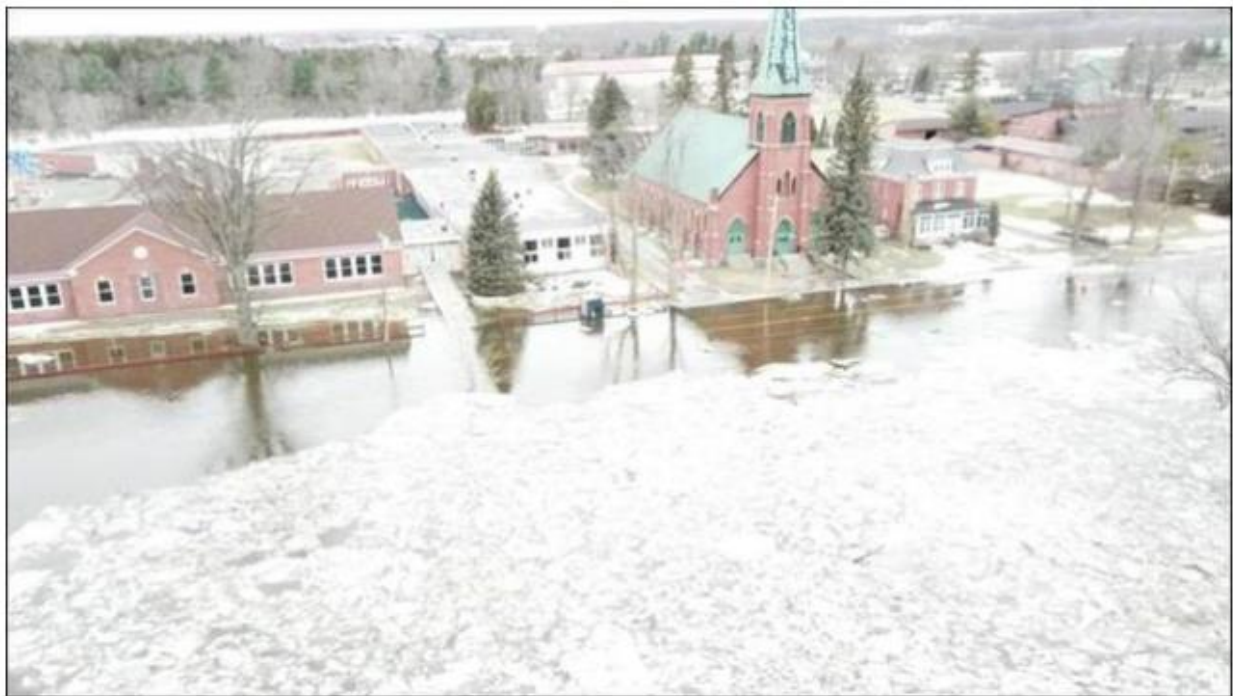
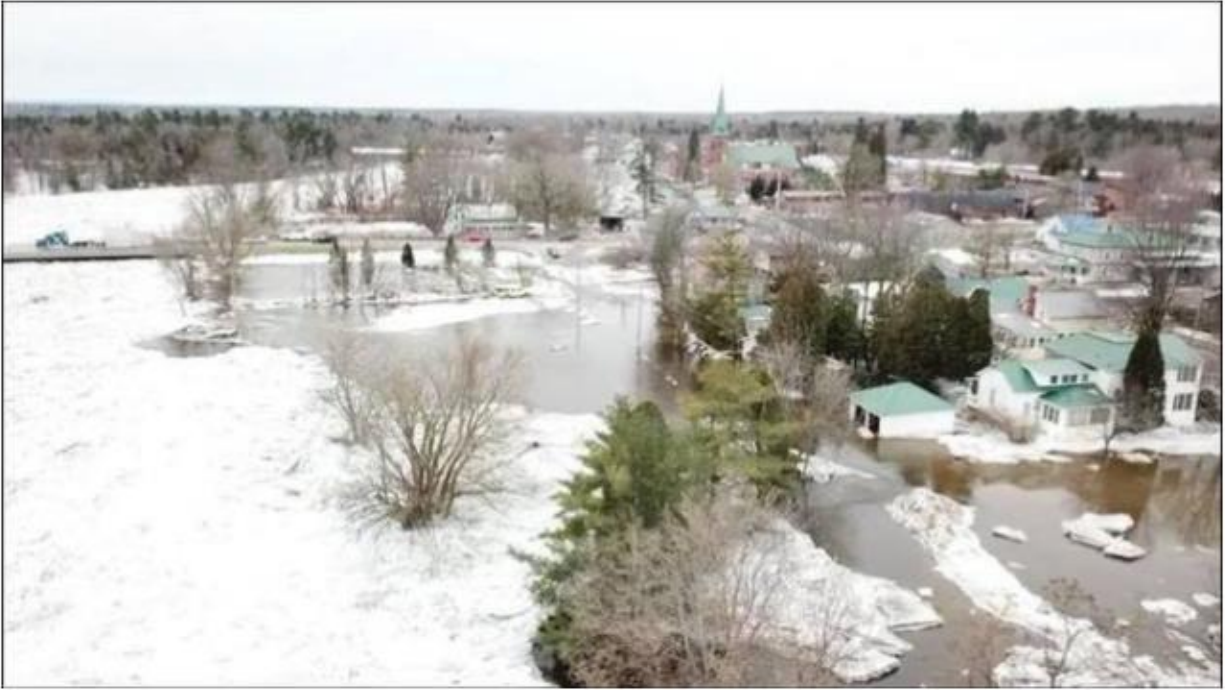
Figure 60. 2018 February ice jam flooding at Hogansburg. Courtesy of SRMT Police.  
([https://www.newyorkupstate.com/northern-ny/2018/02/flooding\\_ice\\_jams\\_in\\_north\\_country\\_see\\_video\\_photos\\_along\\_st\\_regis\\_river.html](https://www.newyorkupstate.com/northern-ny/2018/02/flooding_ice_jams_in_north_country_see_video_photos_along_st_regis_river.html))

Another warm period with warm air temperature and steady rainfall occurred between Feb. 20 and 22 resulted in approximately seven miles of ice cover breakup along with the release of the January jam. An ice jam formed again downstream of the dam site and caused severe flooding. It was reported that fifteen rescues were performed to remove trapped residents. Ninety-six people had evacuated and were staying in hotels or with family. Power had been knocked out at a substation for ten hours on Feb. 22, 2018. Figure 60 shows the 2018 February ice jam flooding at Hogansburg. ([https://www.newyorkupstate.com/northern-ny/2018/02/flooding\\_ice\\_jams\\_in\\_north\\_country\\_see\\_video\\_photos\\_along\\_st\\_regis\\_river.html](https://www.newyorkupstate.com/northern-ny/2018/02/flooding_ice_jams_in_north_country_see_video_photos_along_st_regis_river.html))

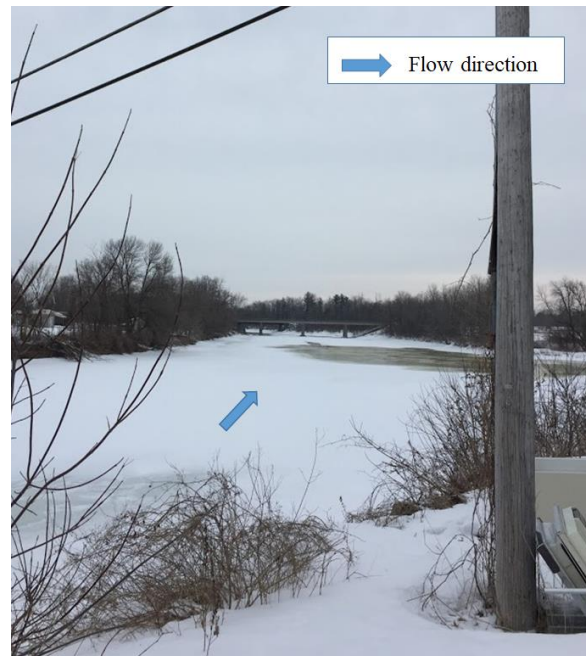
Figure 62. Observed ice condition at the downstream of Helena Bridge, Mar. 15, 2019.

This is a borderline case for a mechanical breakup in mid-March. Figure 61 shows the flow and weather of the winter. Heavy rain on the night of Mar. 13 was followed by a warm period between March 14 and 15 increased discharge and water level. However, this short period of the rainfall in the night did not lead to large surface runoff and rapid increases in discharge and water level to cause the cover breakup. The following two days were warm but no precipitation. The ice cover melted in place, as shown in Figure 62.

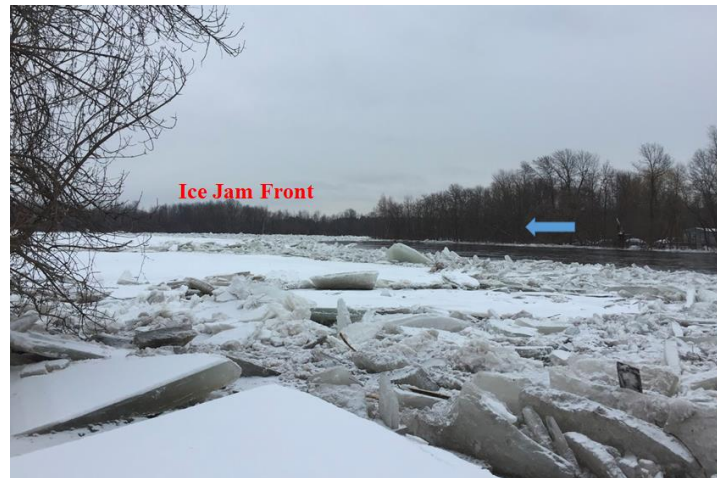
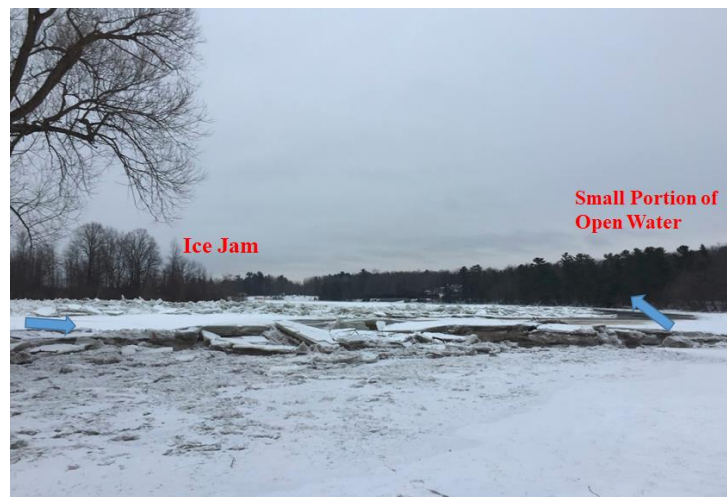
Figure 64. Ice jam formation Jan. 13, 2020.

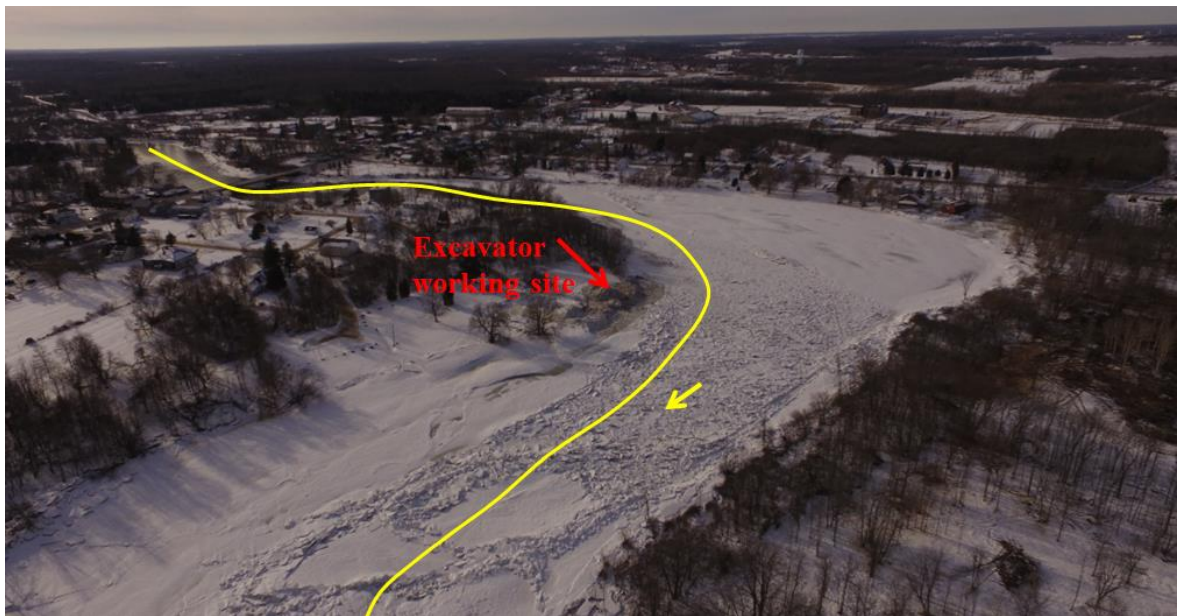
Figure 66. Ice condition at the Hogansburg on Jan. 30. The yellow line indicates the main flow path. Due to the high spots and shallow areas along the outer bank, the main flow path is closer to the inner bank. The effective ice passage in the sharp bend is limited. The ice discharge from the breakup of the upstream ice cover exceeds the ice transport capacity of the bend and form the ice jam at the bend exit against the ice cover downstream.

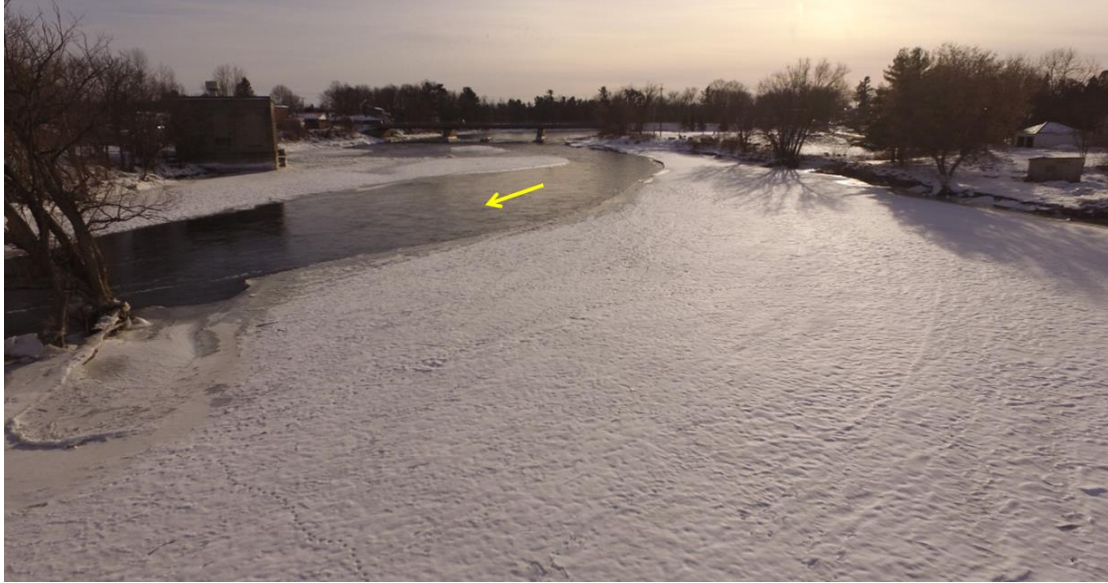
Figure 67. The aerial photo on the flow and ice condition at the bend entrance on Jan. 30. The ice cover extends to about 70% of the channel width and reaches the submerged island. The open water strip indicates the main flow path where the lateral growth of the ice cover ice stopped due to the high velocity except for very cold periods.

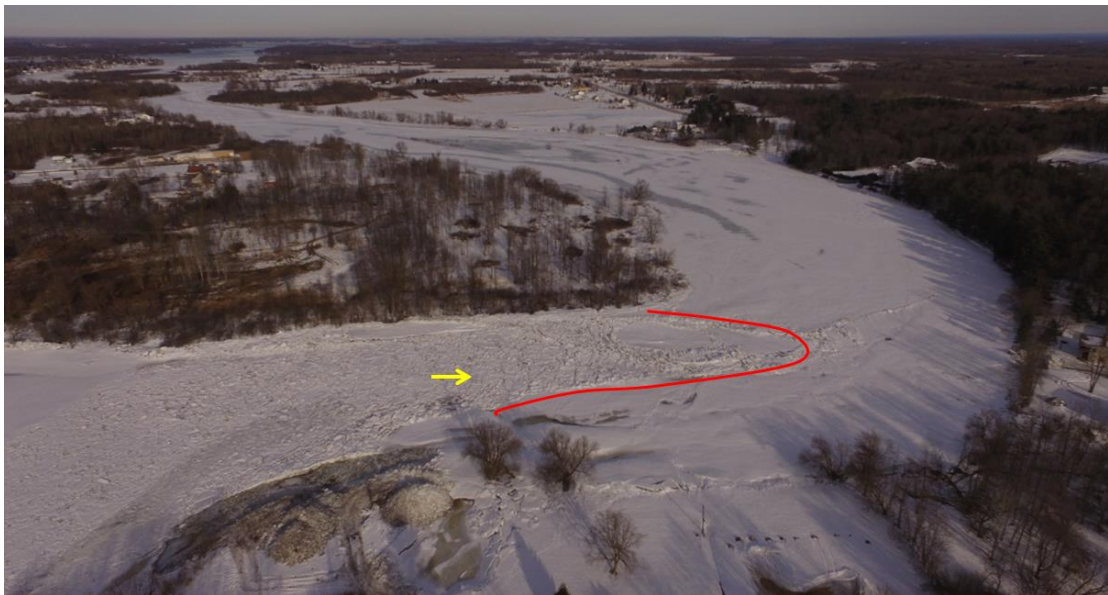
Figure 68. Aerial photo of the ice jam toe on Jan. 30. The red line indicates the ice jam front against the ice cover downstream.

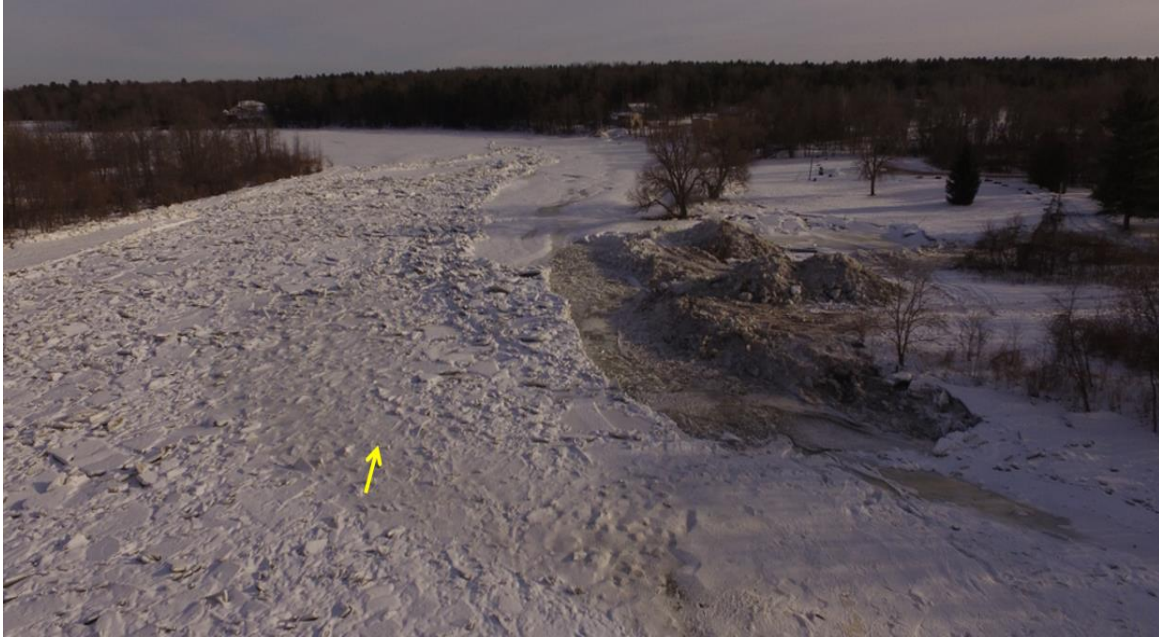
Figure 69. The aerial photo on ice jam and the excavator working site on Jan. 30. Although the removal of the ice accumulation by excavator was a small fraction of the cross-section, it was close to the main flow path and increased the flow to downstream. As a result, it alleviated the high water level caused by the ice jam.
